NASA TN D-6599

ANALYSIS OF SURVEYOR III TELEVISION CABLE AFTER RESIDENCE ON THE MOON

by Frederick C. Gross and John J. Park

Goddard Space Flight Center

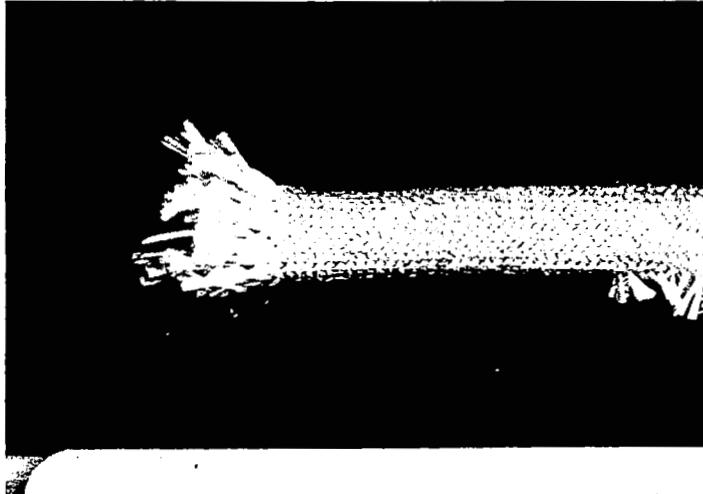
Figure 1—Surveyor cable, glass fabric covering over nineteen insulated wires. (1.5X)

The Surveyor cable, as was mentioned previously, consisted of a glass fabric sleeve over 19 insulated wires (Figure 1). The fabric itself appeared to be a dirty gray, darker than the TAT sample. Some small particles, presumably lunar dust, were noted on the fabric (Figure 2); these particles were neither large nor very numerous. In addition, it was noted that the TAT sample also had loose pieces of metal or dirt in its fabric sleeve. However, the Surveyor sample had more particles and was darker.

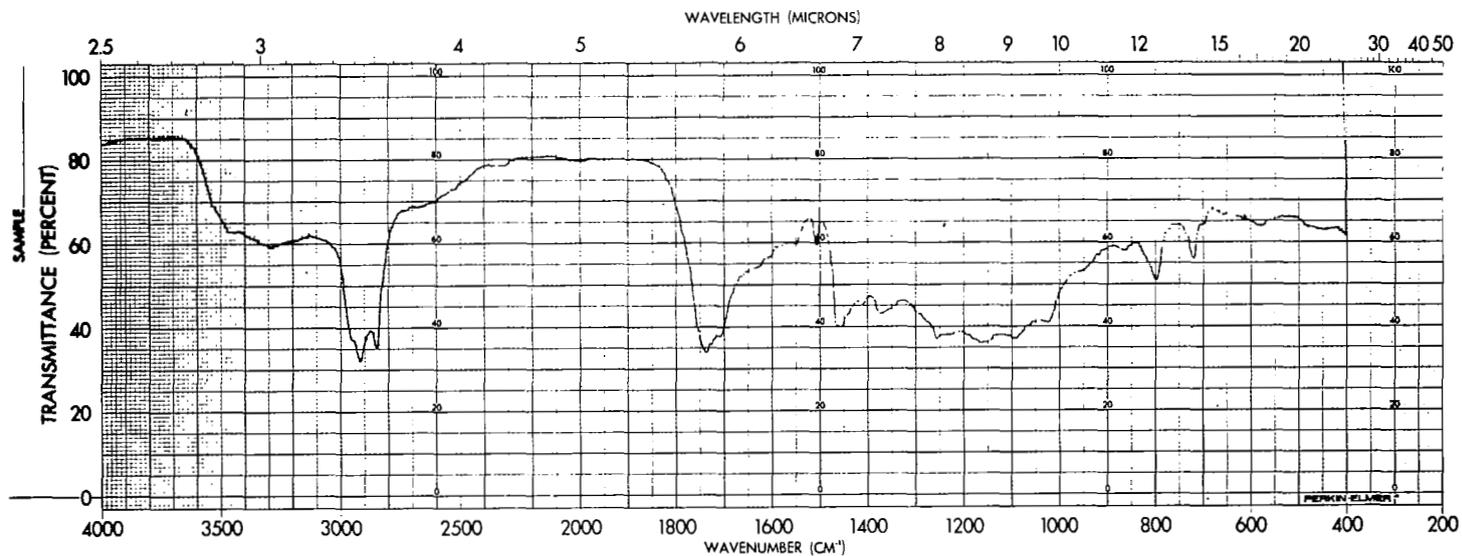
Figure 3(a)—Reproduction of spectrum of chloroform extract from TAT glass fabric. [The SI equivalent of the micron (μ) is the micrometer (μm); $1 \mu = 1 \mu\text{m}$.]

Samples of fabric were extracted with boiling chloroform. The chloroform was evaporated, and the weights of the extracts were determined. The comparison of these results was positive: The TAT sample had a 0.32-percent residue, and the Surveyor sample had a 0.21-percent residue. The residues were dissolved again, and their infrared spectra were obtained. The spectrum of the TAT sample [Figure 3(a)] showed mostly aliphatic esters and other carbonyl-containing compounds such as fatty acids. The spectrum of the Surveyor sample [Figure 3(b)] was a more clearly defined pattern of aliphatic esters, which indicated that some volatilization of the lower-boiling constituents might have occurred in the space vacuum.

The extracts were then examined by gas chromatography, which separates the constituents of a vaporized sample into distinct fractions. This confirmed that the extract from the Surveyor sample has less volatile components than that from the TAT sample.

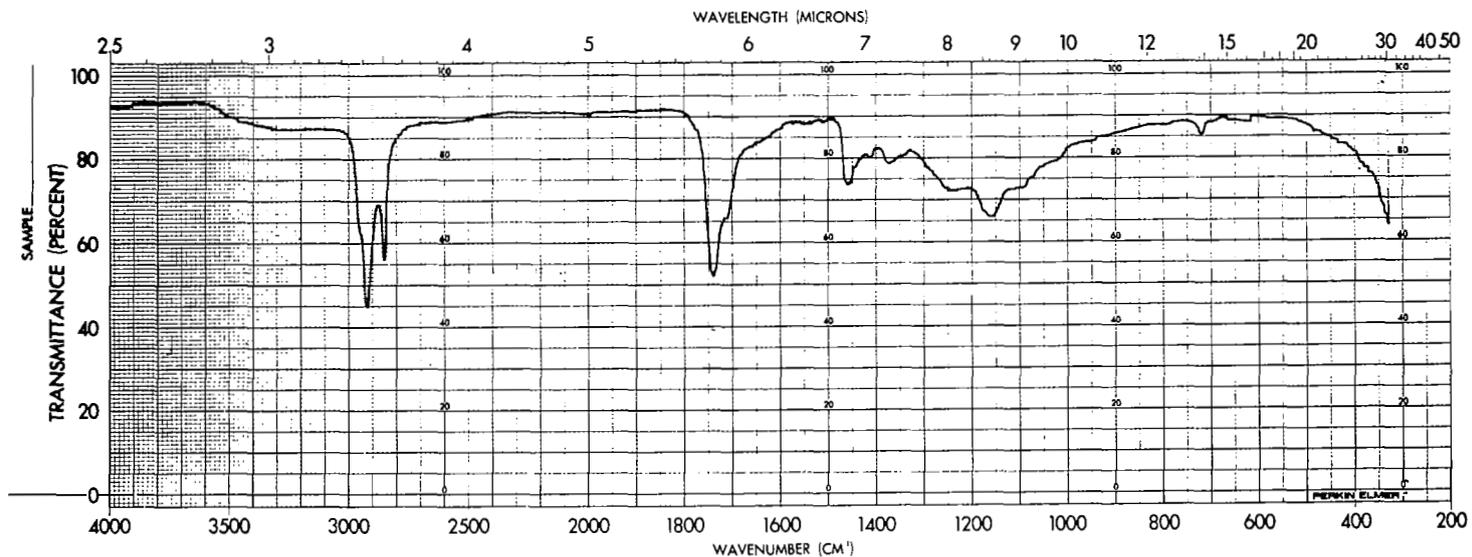
Figure 3(b)—Reproduction of spectrum of chloroform extract from Surveyor glass fabric. [The SI equivalent of the micron (μ) is the micrometer (μm); $1 \mu = 1 \mu\text{m}$.]

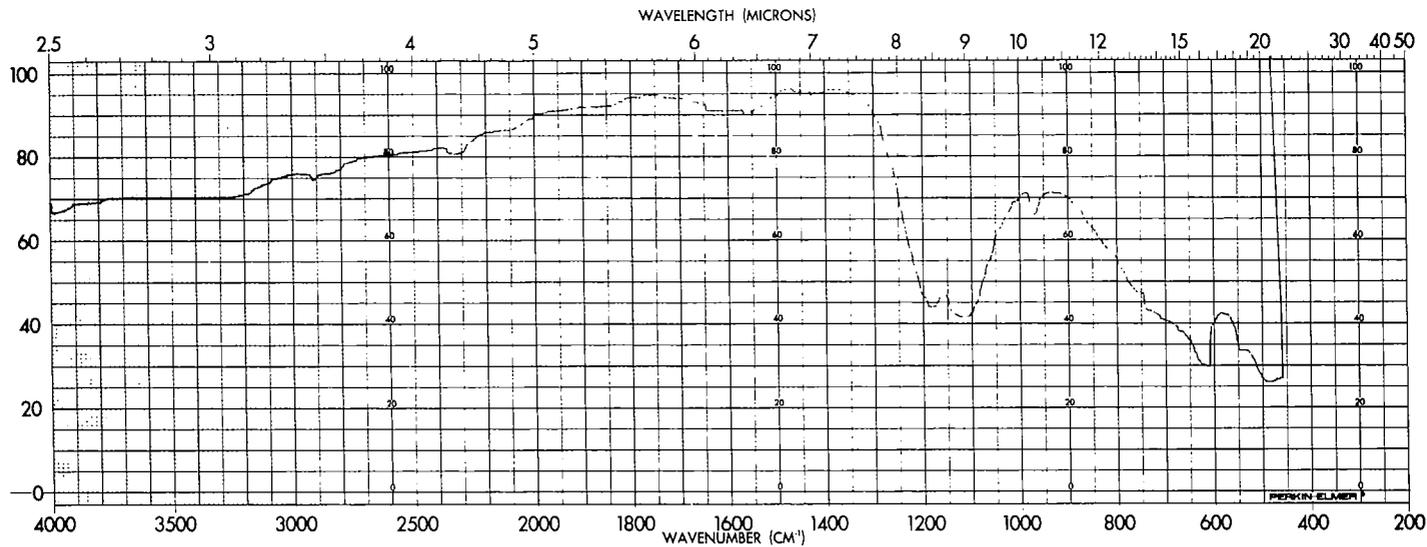
Figure 4(a)–Reproduction of ATR-IR chart of TAT Teflon insulation. [The SI equivalent of the micron (μ) is the micrometer (μm); $1 \mu = 1 \mu\text{m}$.]

Dissolution of the outer polyimide layer by a 15-percent hot potassium-hydroxide solution was carried out. The underlying Teflon layer of the Surveyor sample showed some small areas of slight discoloration. The ATR-IR patterns yielded some slight differences in the region of 800 to 500 cm^{-1} , though it would be difficult to assign positive significance to these because of the normal variations of the test [Figures 4(a) and 4(b)]. The bands in the region of 2900 cm^{-1} in Figure 4(b) are considered to be a residual contaminant on the infrared reflectance crystal.

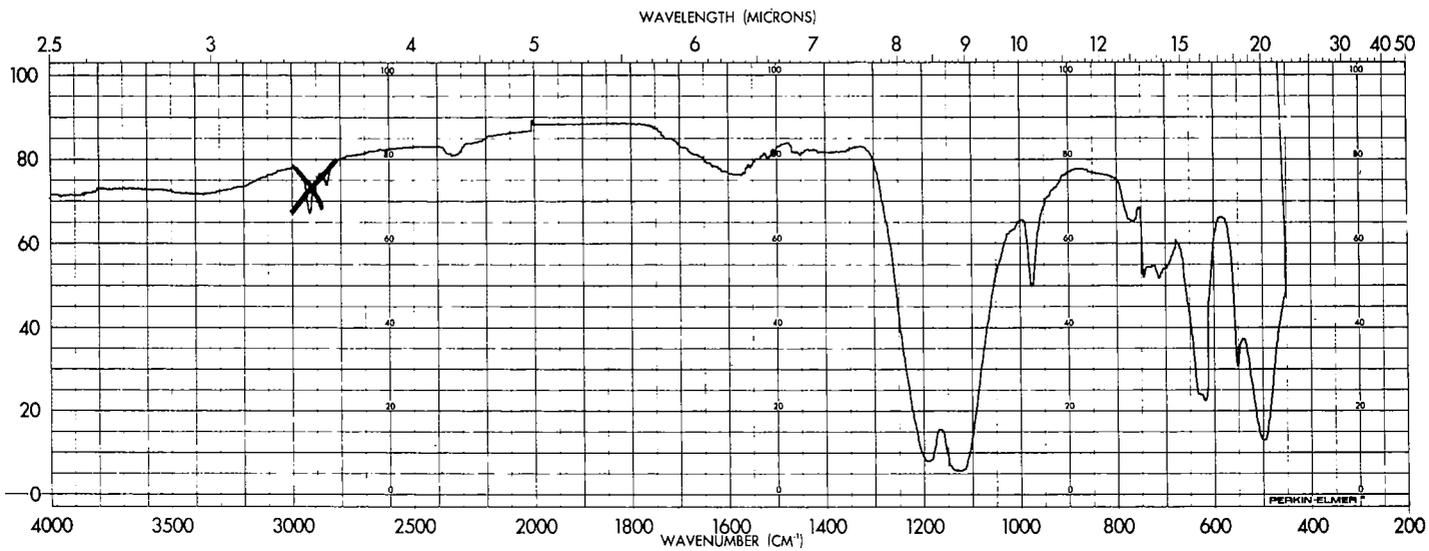
Figure 4(b)–Reproduction of ATR-IR chart of Surveyor Teflon insulation. [The SI equivalent of the micron (μ) is the micrometer (μm); $1 \mu = 1 \mu\text{m}$.]

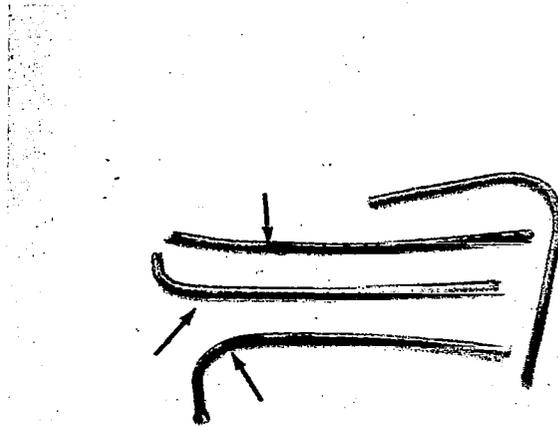
Certain portions of at least two Surveyor wires showed black areas (Figure 6). It was determined that these areas were under the insulation rather than on the surface. These areas were examined in an electron microprobe analyzer. These results showed primarily silver and copper, but also sulfur and iron; the sulfur was associated with the silver rather than with the iron. The X-ray diffraction pattern identified the black areas as silver sulfide, Ag_2S . There were also occasional areas on the wires that were determined to be high in copper and sulfur, possibly copper sulfate, $CuSO_4$. It must be assumed that the sulfide corrosion was on the wires before the trip to the moon, though it should be pointed out that no such areas were observed on any of the TAT wires.

Figure 6--Surveyor wires showing corrosion on three separate wires; fourth wire with large bend is from TAT.
